Reference: Internal Investigation Unit 29 and Chimney, Northface Condominiums, North Conway, NH

Northface Condominiums – Thompson Road, North Conway, NH

Northface Condominiums  
Building 3 East Chimney &  
Unit 29 Thimble  
Internal Investigation Findings

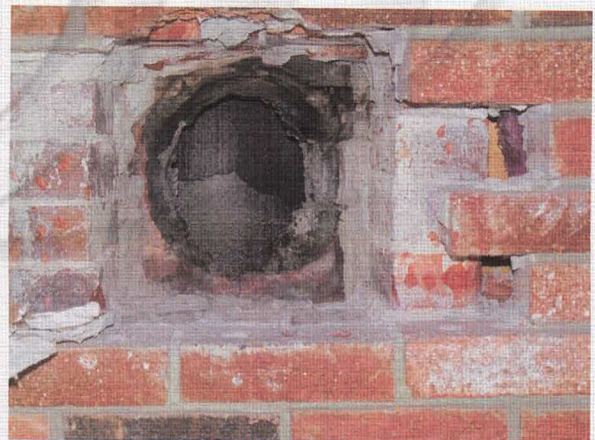
In a wood stove installation, the “thimble” is the component that the stoves chimney connector connects to so that flue gases can pass from the stove, through the chimney connector (which is connected to the thimble) and then through the thimble into the chimney flue. In the chimneys at Northface the thimbles are installed in and through the brick masonry that covers the wall behind the wood stoves. In Unit #29, the area around the thimble, as the thimble passes through the masonry wall into the chimney, was surrounded by mortar and brick. Specifically, there was a brick “box” constructed around the metallic thimble. Then, the annular space (or gap) between the

somewhat square brick frame and the round thimble was filled with mortar. The dimension of the area filled with mortar was approximately 12" high by 12" wide, inside the brick "walls" which were found to be on the top, bottom, and sides. In the case of Unit #29, the thimble was found to be a double-wall "metalbestos" (trade name for insulated double wall stainless steel chimney pipe) insulated vent connector. The minimum clearance to combustibles for this type of connector is not specified within the codes but instead is always based on the manufacturer's specific details or "listing," which in this case we do not have as we do not know the manufacturer of the specific product that had been used. Usually however, similar materials are listed to be installed no closer than 6" to combustible materials.

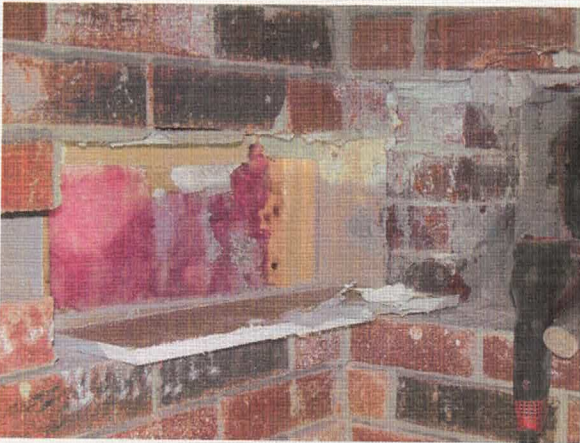
A section of the protective masonry behind the stove was removed which allowed access to and observation of the otherwise concealed area behind the brick. We were comforted to see that gypsum wallboard had been applied to the face of the wall framing and after removing a small section of gypsum, we were comforted to find insulation to have been installed between the studs. We observed and noted that the studs visually were in good condition despite that the area that we viewed was quite close to where the chimney connector would be located, immediately adjacent to the thimble. Visually, no area of the wood studs that were viewed appeared to have experienced pyrolysis, were

visually charred or exposed to elevated temperature, or otherwise showed any adverse effects from elevated and/or extended high-heat exposure.

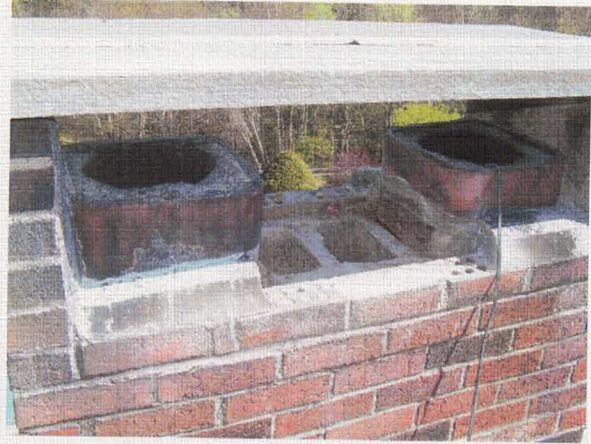
Within each chimney there are two 12" x 12" (outside dimension) 11" x 11" (inside dimension) terracotta flues. Each flue is placed towards the outer edges of the chimney with the space in between the two flues being taken up by a block masonry divider. In the case of the chimney that was opened, each of the flues had been lined with a liner system locally known as the Ahren's method. The perimeter of the interior of each flue has been filled with a proprietary mortar which is installed after sliding an 8" cylindrical form down the chimney. Using this Ahren's method, after the mortar sets up (hardens) around the form, the cylindrical form is removed, leaving behind a round, 8" flue inside what had been an 11" square. Please know that we don't believe each flue in every Northface chimney has had this lining but, for those that have been lined using this method, please know that a round flue is more efficient than a rectangular or square one, but the available flue area has been reduced and this mortar "liner" cannot be removed without destroying the original terracotta flue. IF the two existing flues and the masonry block divider could successfully be removed, we do not believe it possible to properly install six individual flues of appropriate size to serve six solid fuel burning appliances.
