Northface Resort Condominium Association

Special Meeting Flues and Fireplaces **XX July 2023**

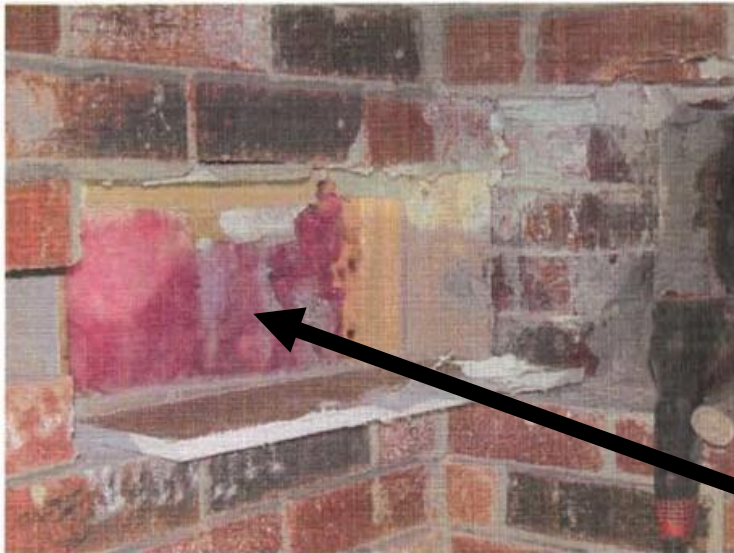
- 2021/2022: Association retained ‘Fire Engineer’ (Bergeron Technical Services) to evaluate situation and conduct a sample demo (Unit 29)
 - No evidence of Pyrolysis which had been the major concern

Pyrolysis: ‘Materials that have become visually charred or exposed to elevated temperature, or otherwise showed any adverse effects from elevated and/or extended high-heat exposure’

Brick removed and drywall cut showing studs and insulation

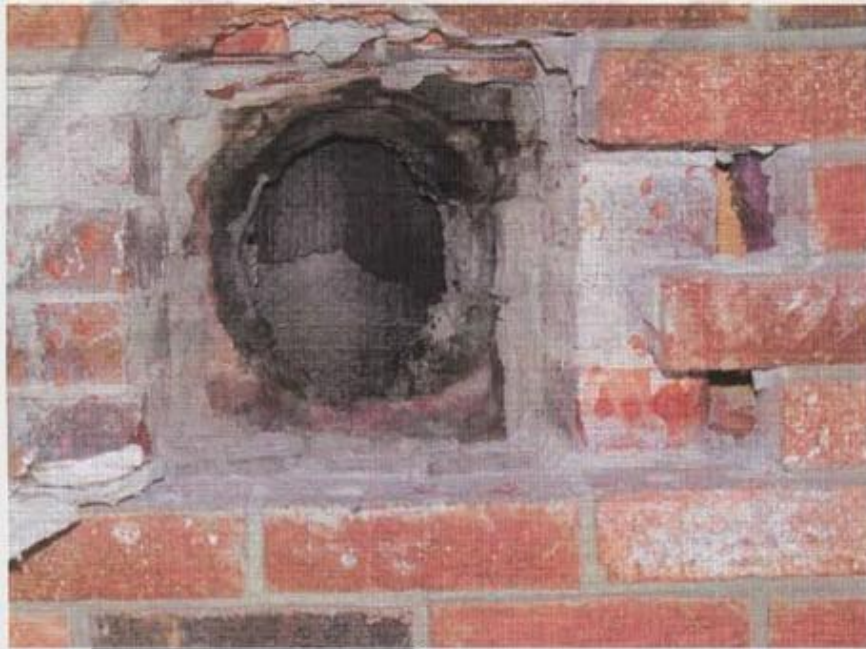
Unit 29 (Bldg 3) Selective Investigative demo

- Thimbles fine (Key component in chimney linking stove to flue)

- *‘Thimble found to be double-wall insulated double wall stainless steel.*
- *Minimum clearance to combustibles not specified in codes but always based on manufacturer's "listing,"*
- *While manufacturer can not be determined, similar materials are listed to be installed no closer than 6" to combustible materials.’*

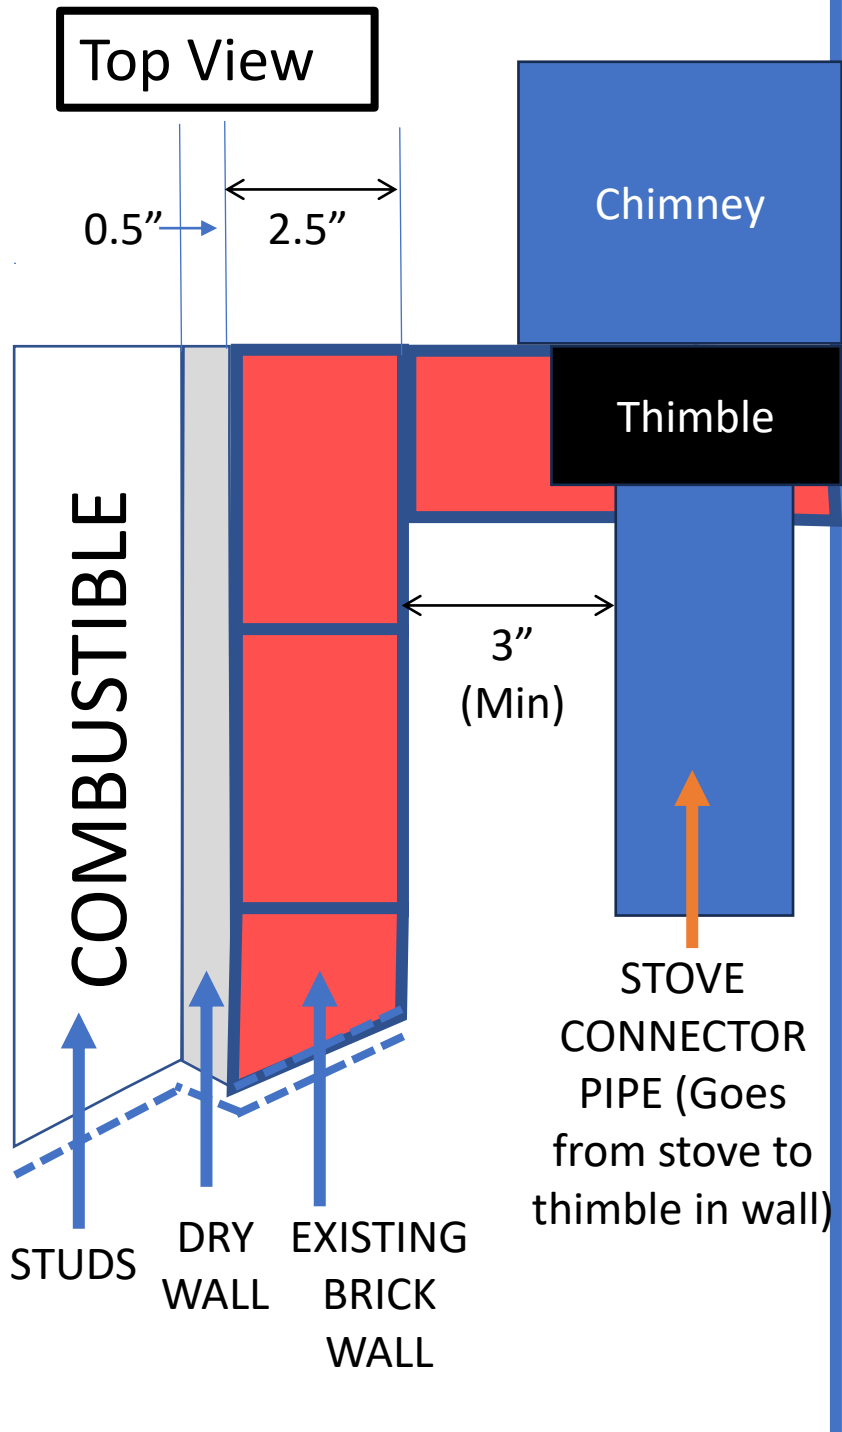
- Despite good condition, most thimbles need to be replaced
 - Many too close to combustibles (details in later slides) to allow code required distance for stove connector pipe
 - Bldg 2 and 3 – Will be replaced as part of reconstruction
 - Bldg 1 and 4: Some were different configuration - not all are doubled walled construction (as Unit 29 sample demo)

Need 3 in minimum from existing brick wall to stove connector pipe to meet code

- 18 inches required by code (from stove connector pipe to combustibles) unless one of two mitigation techniques used:
 - 1 in air gap behind brick (no Northface unit has – would require hearth rebuild
 - Use of “Double walled” stove connector pipe
- Mitigation allows a 66 2/3% reduction in clearance or $18/3 = 6$ inches
- Drywall and existing brick = 3 inches
- Thus need 3 inches minimum between stove connector pipe and brick ($6-3 = 3$)

Units having 3 inches (pipe to brick) would not require a new thimble (to move the pipe over)
