Northface Resort Condominium Association

Special Meeting Flues and Fireplaces **XX July 2023**

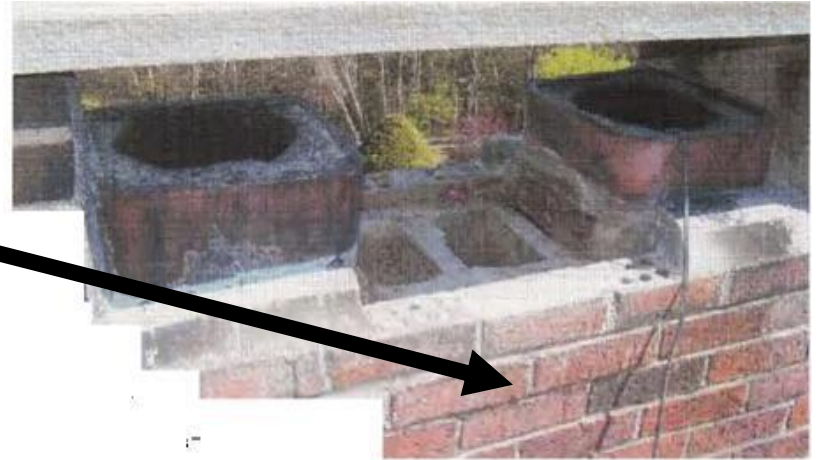
Option 1: Modify Existing Chimneys to house six, 6-inch steel flues

- Cut entire wall facing Thompson Road and remove material
- Insert six, 6-inch steel flues into cleared space/insert new thimbles
- Rebuild front wall
